NASA/TM-2001-210846

Structural Testing of a Stitched / Resin Film Infused Graphite-Epoxy Wing Box

*Dawn C. Jegley and Harold G. Bush
Langley Research Center, Hampton, Virginia*

April 2001

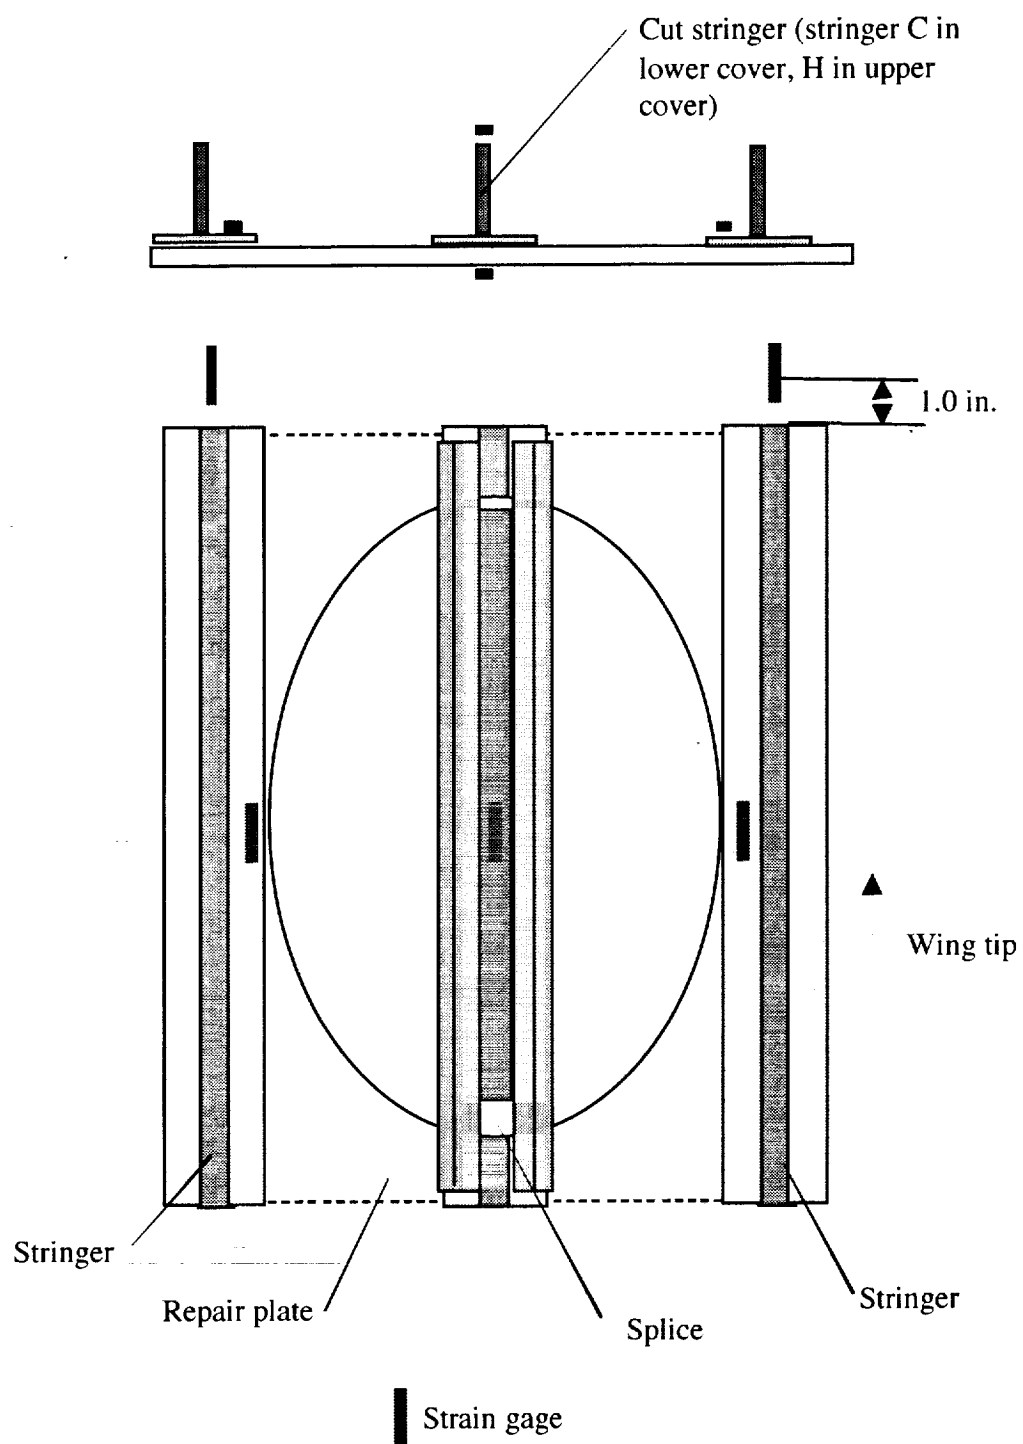
Both sawcuts were repaired prior to the final test (test 8). The strains measured in the lower cover panel repair are shown in figure 64. The solid line represents strain in the metal component of the spliced blade. The short dashed line represents the strain in the metal repair plate. The long dashed lines represent the strain at the edges of the repair bole. The alternating long and short dashes represent the strain in the composite skin immediately outboard of the metal plate. The location of these strain gages is shown in figure 14. Strains on the composite structure in the vicinity of the repair are linear and do not exceed 0.005 in./in. Strains in the metal repair components display nonlinearity but remain less than 0.003 in./in.

The strains measured in the upper cover panel repair are shown in figure 66. The solid line represents strain in the metal component of the spliced blade. The short dashed line represents the strain in the metal repair plate. The long dashed lines represent the strain at the edges of the repair hole. The alternating long and short dashes represent the strain in the composite skin immediately outboard of the metal plate. The location of these strain gages is shown in figure 14. Strains on the composite structure in the vicinity of the repair are linear and do not exceed 0.005 in./in. Strains in the metal repair components display nonlinearity but remain less than 0.003 in./in.

Figure 14. Strain gages at repair sites.

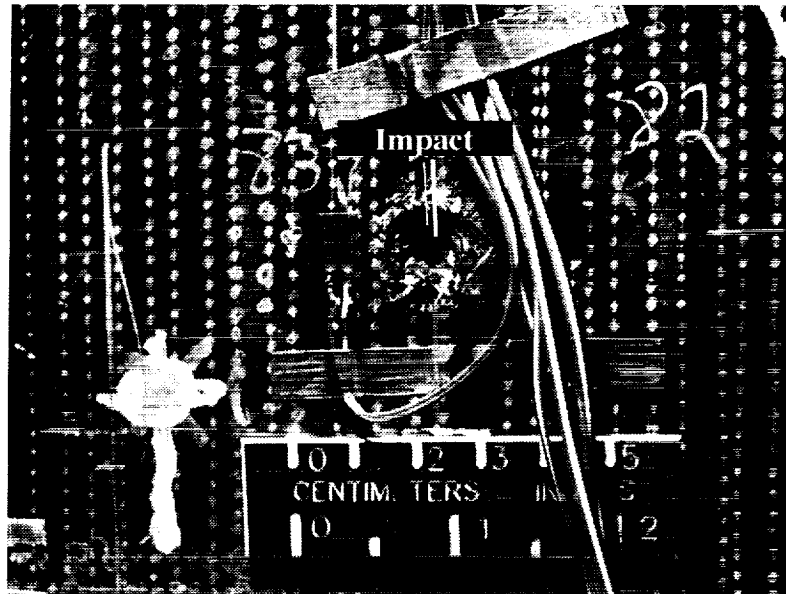
a) Site at rib 4

Figure 15. Lower cover impact damage locations.

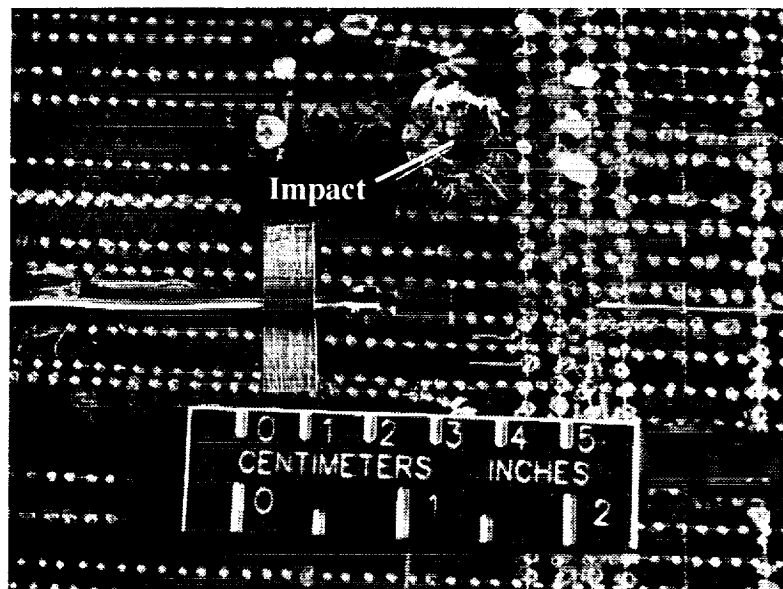
b) Site at rib 8

Figure 15. Continued.

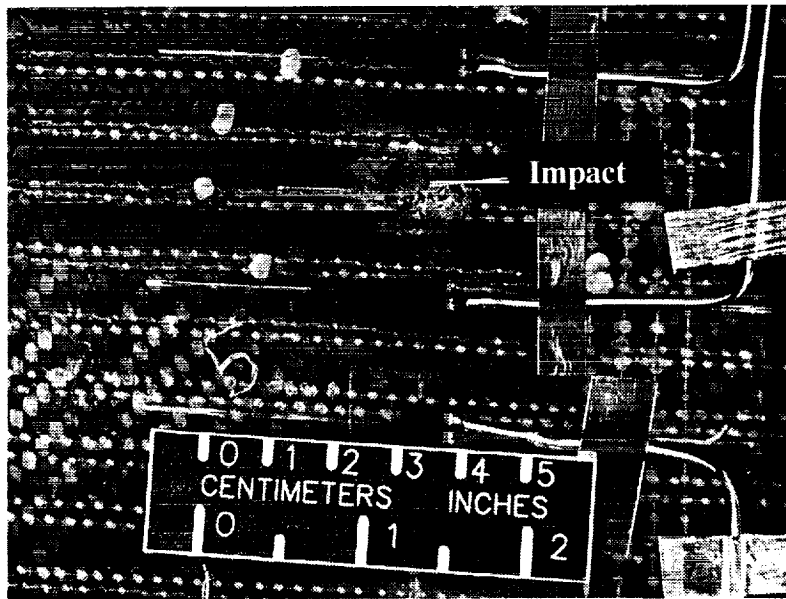
Strains in lower cover panel with impacts are shown in figures 71, 72 and 73 for impact sites at rib 4, rib 8 and rib 12, respectively. Internal strains are shown with dashed lines and external strains are shown with solid lines. The lines with filled symbols represent strain of the undamaged structures. Strains within 1 inch of the impact site remain linear and increase by less than 4 percent compared to strains in the undamaged structure for the impacts at the three impact sites. The impact at rib 12 was originally intended to be at rib 13 (shown in figure 1), so the test article was strain gaged with the corresponding gage pattern. However, the impact site had to be moved because it was impossible to impact the lower cover so close to the rib 13 load saddle. Internal gages could not be moved or added to the rib 12 location. So strains at the rib 12 impact site can only be compared to one gage on the undamaged structure, as shown in figure 73.

c) Site at rib 12
Figure 15. Concluded.

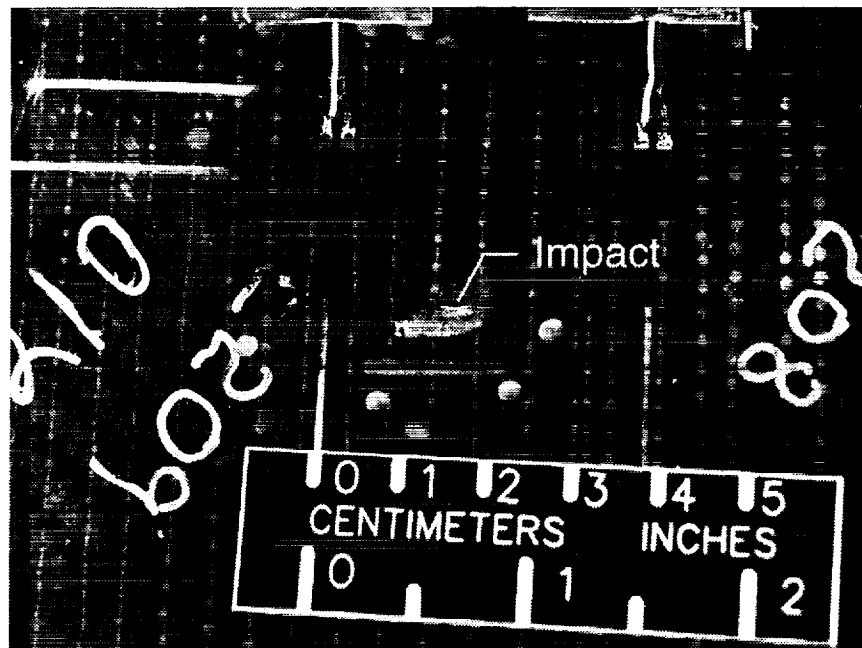
b) Site at rib 13
Figure 16. Concluded.

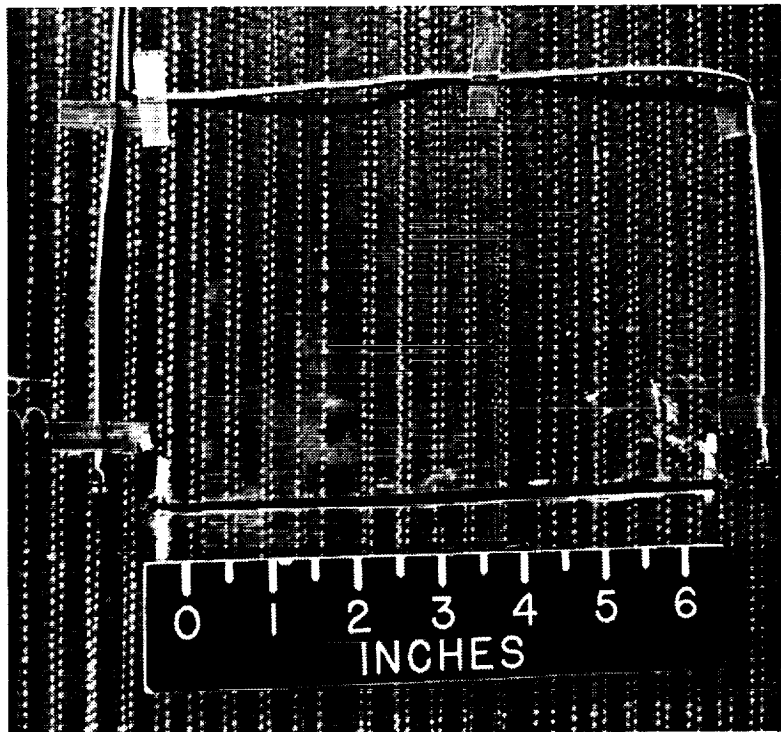
The effect of the sawcut on the behavior of the test article can be seen by comparing the strains measured in test 6 when the wing was loaded to DLL to the strains measured in test 7 in the presence of the sawcut. Axial strain gages were located on the internal and external skin at the sawcut tips and on the adjacent (uncut) stringers. These gage locations are shown in figure 12. Strain measured near the sawcut in the lower cover panel is shown in figure 62a and strains measured near the sawcut tips in the upper cover panel are shown in figure 62b. Internal strain is represented by solid lines and external strain is represented by dashed lines in the figures. Open symbols represent strain in the sawcut-damaged structure. Filled symbols represent strain in the undamaged structure. Strains at the sawcut tips are more than twice the strains at the same location in the undamaged structure. Strains remain linear for the full load range for the lower cover sawcut but sudden increases in strain occur in the upper cover panel sawcut tips internal surface. However, post-test ultrasonic inspection indicated no damage at the tips.

a) Lower cover panel
Figure 17. Sawcuts.

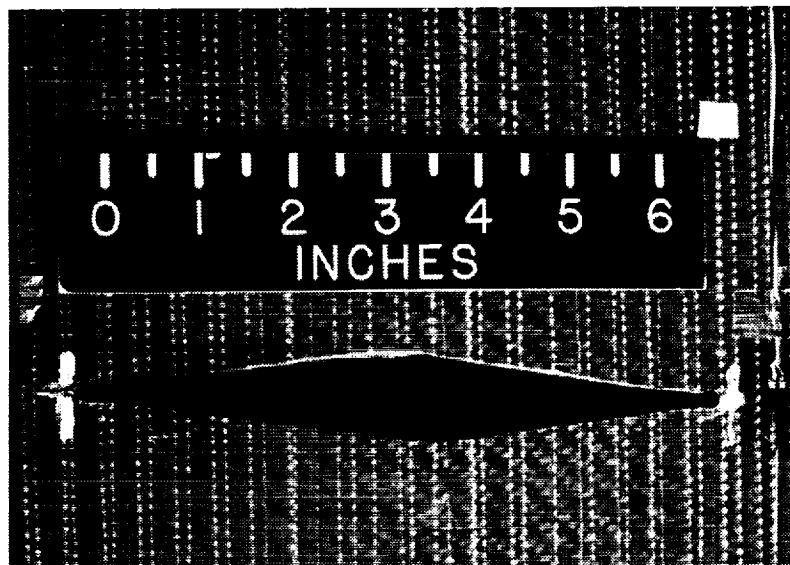
b) Upper cover panel
Figure 17. Concluded.

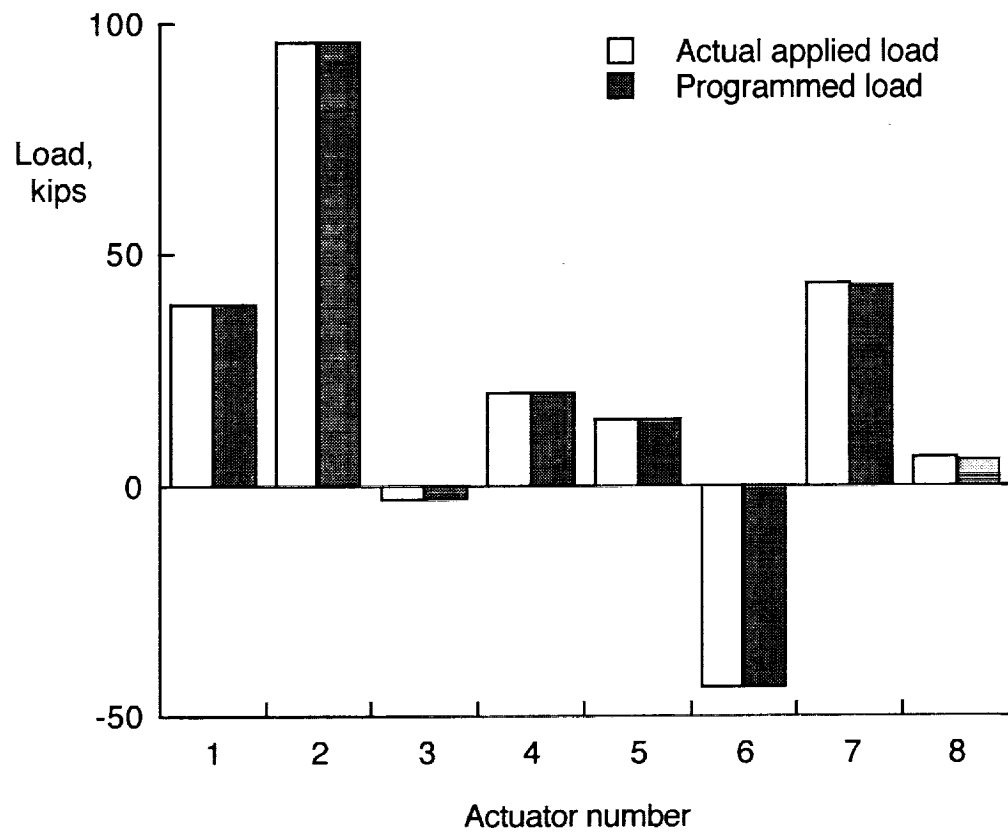
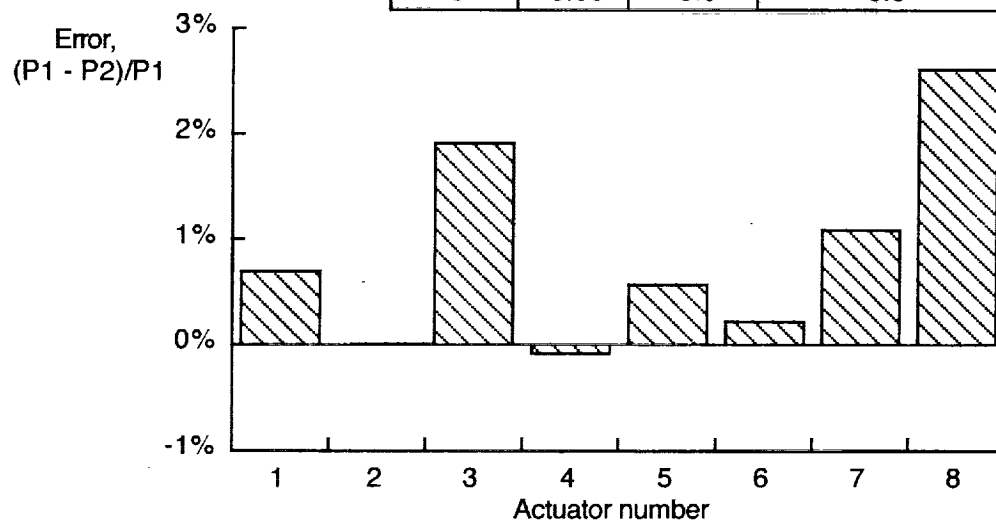
The test article supported 97% of its Design Ultimate Load (DUL) prior to failure. This load corresponds to the actuator load values shown in figure 46. A photograph of the test article loaded at 95% DUL is shown in figure 44. The primary failure location is across the lower cover panel through access hole 4. This region of the lower cover panel after final failure is shown in figure 75. The failure goes through all stringers but primarily remains between ribs 8 and 9. Both spars were also damaged, as shown in figures 76 and 77. Other minor damage was found but appears to be unrelated to the initial failure event. The discussion of the failure will be limited to the regions between ribs 6 and 10, the impact sites and the repairs.

Figure 46. Loading in test to failure in the 2.5G loading condition.

b) Error in applied load where $P1$ = actual load, and $P2$ =programmed load at failure

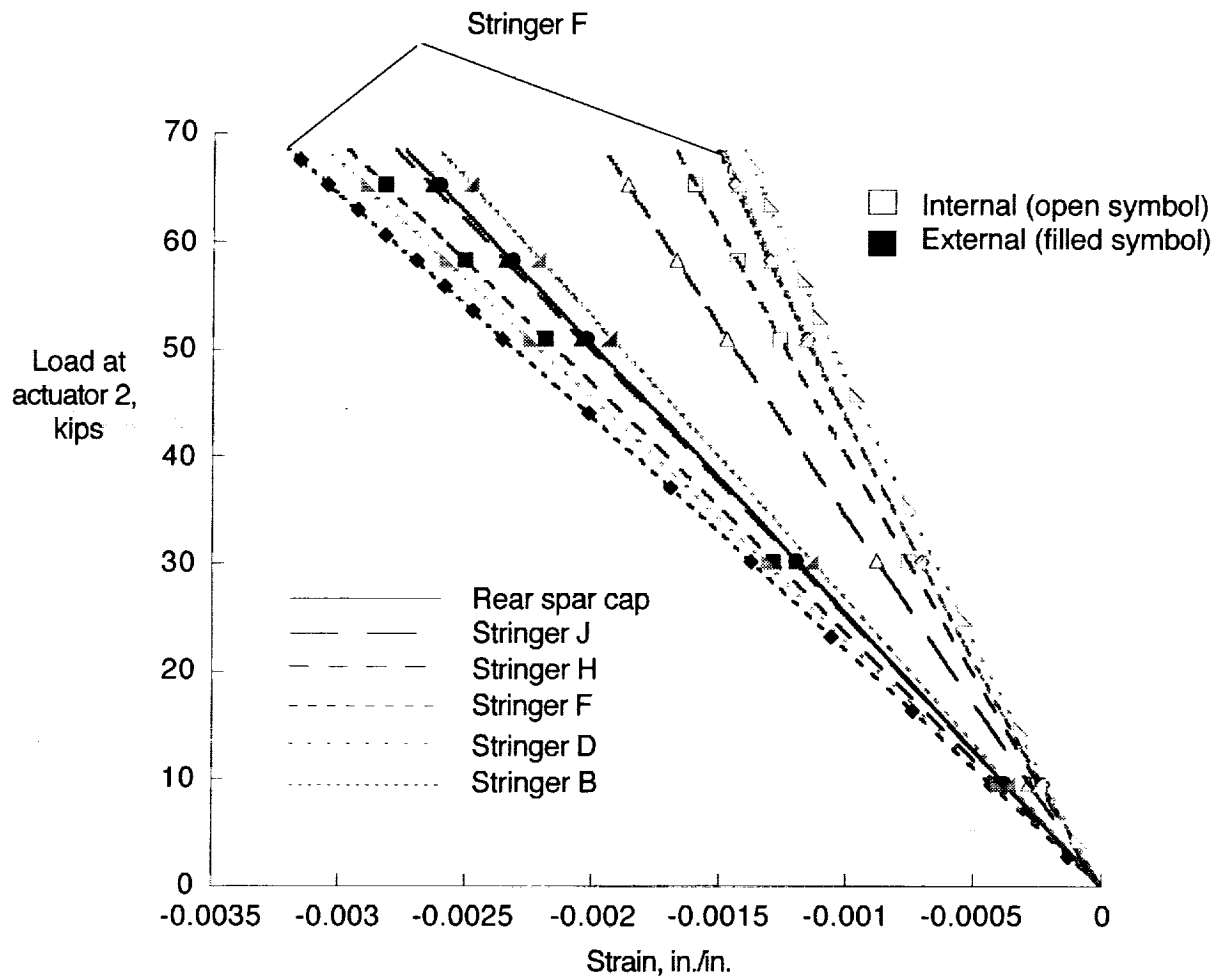
In addition to the global bending behavior illustrated in figure 50, local nonlinear behavior occurred in the upper cover panel to the rear of the rear spar between ribs 8 and 10. An overhang of the cover panel with a width of approximately four inches behind the rear spar left an unsupported edge along the length of the test article. This region is shown on figure 7 as the "critical overhang region." Two back-to-back gages on the skin at the edge of the overhang midway between ribs 8 and 9 indicate that significant local bending occurred. Strains in the upper cover near the rear spar between ribs 8 and 9 are shown in figure 80 for the repaired structure. Open symbols represent strains on the upper skin surface on the cover panel. Filled symbols represent strains on the blade of stringer H and on the lower skin surface of the overhang. For a load less than 70 kips in actuator 2, the local bending effects do not occur (only the global bending effects are seen). However strain reversal is seen in the gages located in the overhang region as load approaches DUL. No other gages were in the overhang region.

Figure 50. Bending in upper cover panel. Strain gage location are shown in figure 7.

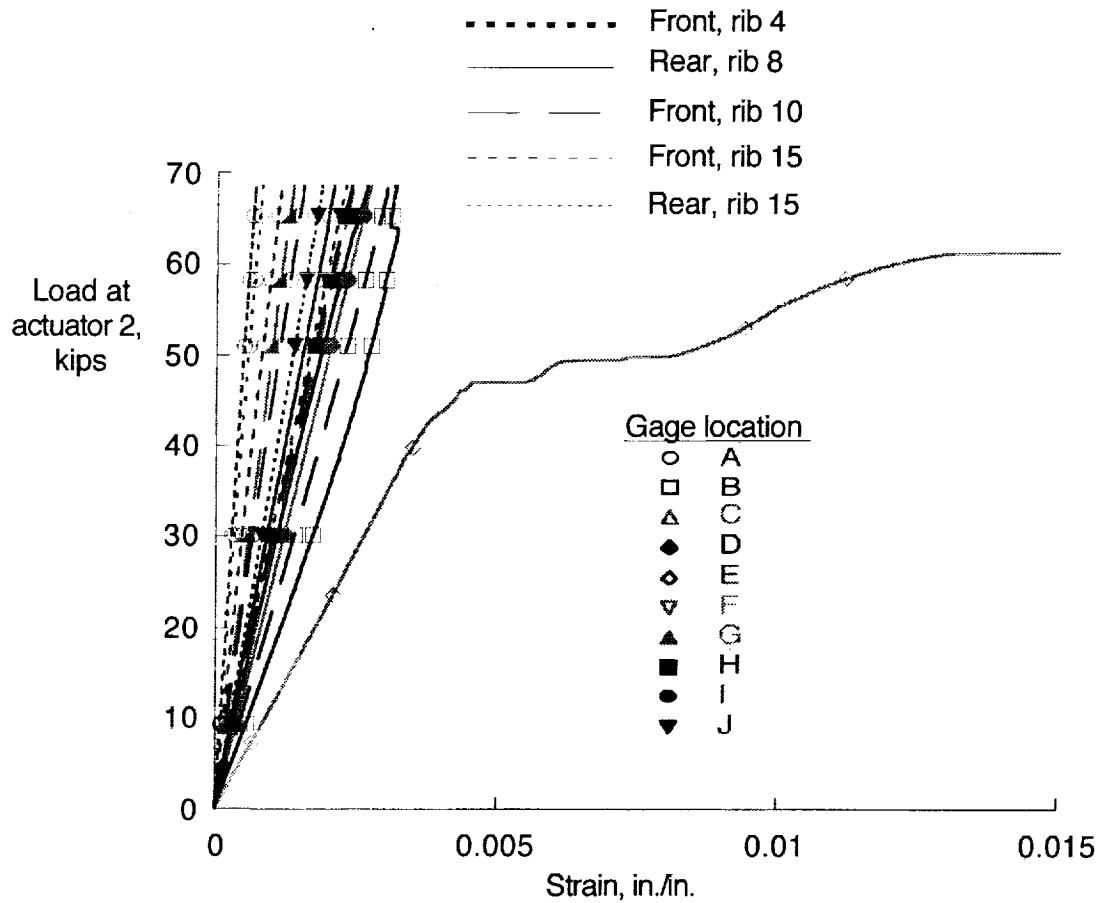
Measured strains at lower and upper cover runouts are shown in figures 52 and 53, respectively. These runouts are identified by the rib at which they terminate and their position front or aft. In the figure the length of the dashes is used to differentiate among runout locations. Symbols represent locations at the runouts. Open symbols represent strains on the interior surface of the test article. Filled symbols represent strains on the exterior surface of the test article. Strain gage locations are shown in figures 3 and 4. The lower cover is loaded in tension in this load condition, so all measured lower cover runout strains are positive. Similarly, the upper cover is loaded in compression in this loading condition, so all measured upper cover runout strains are negative. All runout strains are approximately linear except in the lower cover near the rear spar at rib 8. Strains do not exceed 0.004 in./in in magnitude except at that rear spar runout. At that runout location, gage E records a linear load-strain relationship up to approximately 0.004 in./in. strain, then it records significantly higher strain as load is increased, indicating some damage may have occurred at this location. However, post-test visual and ultrasonic evaluation could not identify any damage at this runout. Strain gage B at that runout displays a small discontinuity in the slope of the load-strain curve at a load of approximately 62 kips. The maximum strains in any upper cover runout location are in the runout at the rear spar at rib 9 as shown in figure 53.

Figure 52. Measured strain at lower cover stringer runouts at DLL for 2.5G load condition. Strain gage locations are shown in figures 3 and 4.

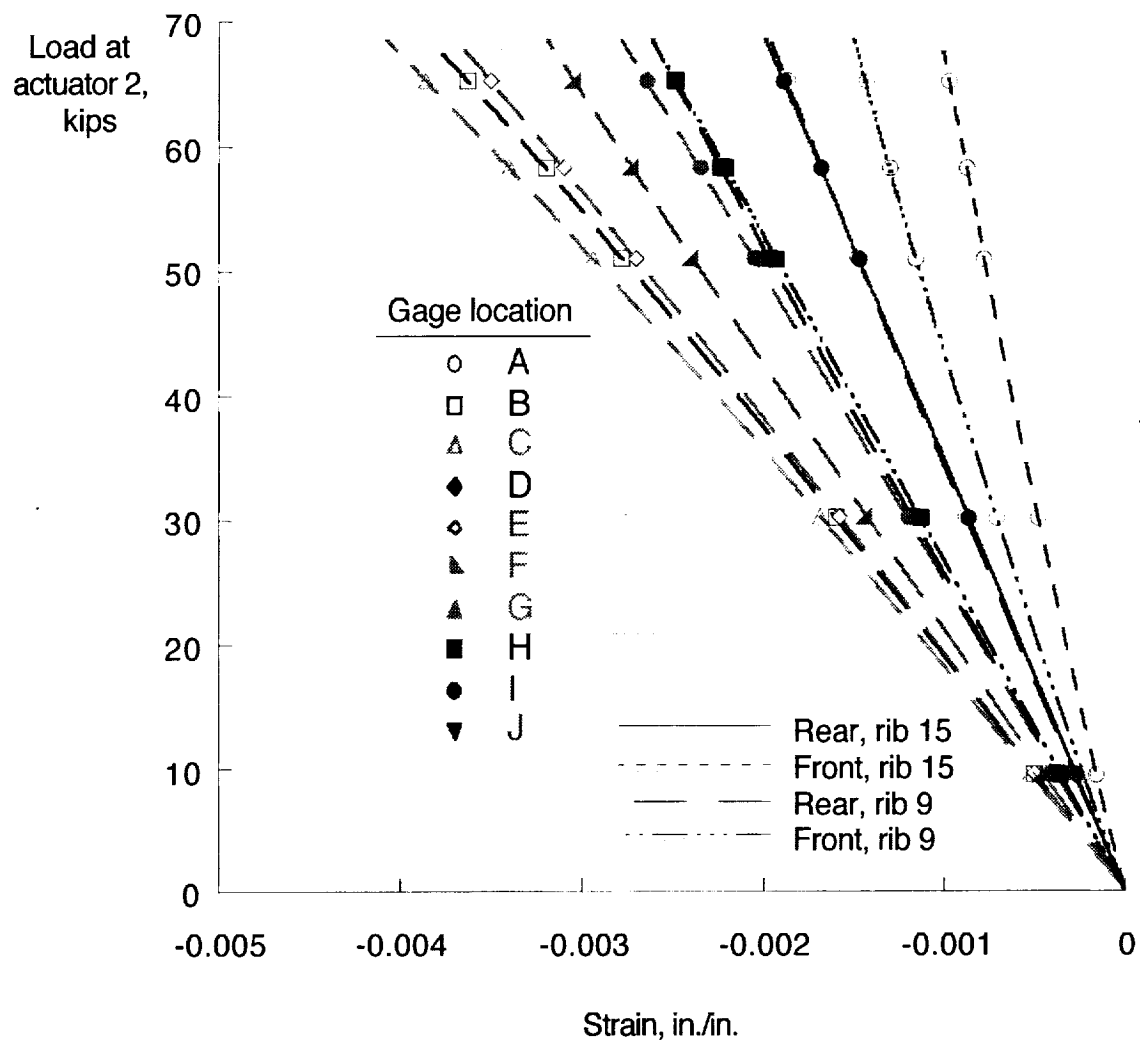
Figure 53. Strain in upper cover stringer runouts for loading to DLL in the 2.5G load condition. Strain gage locations are shown on figures 3 and 4.

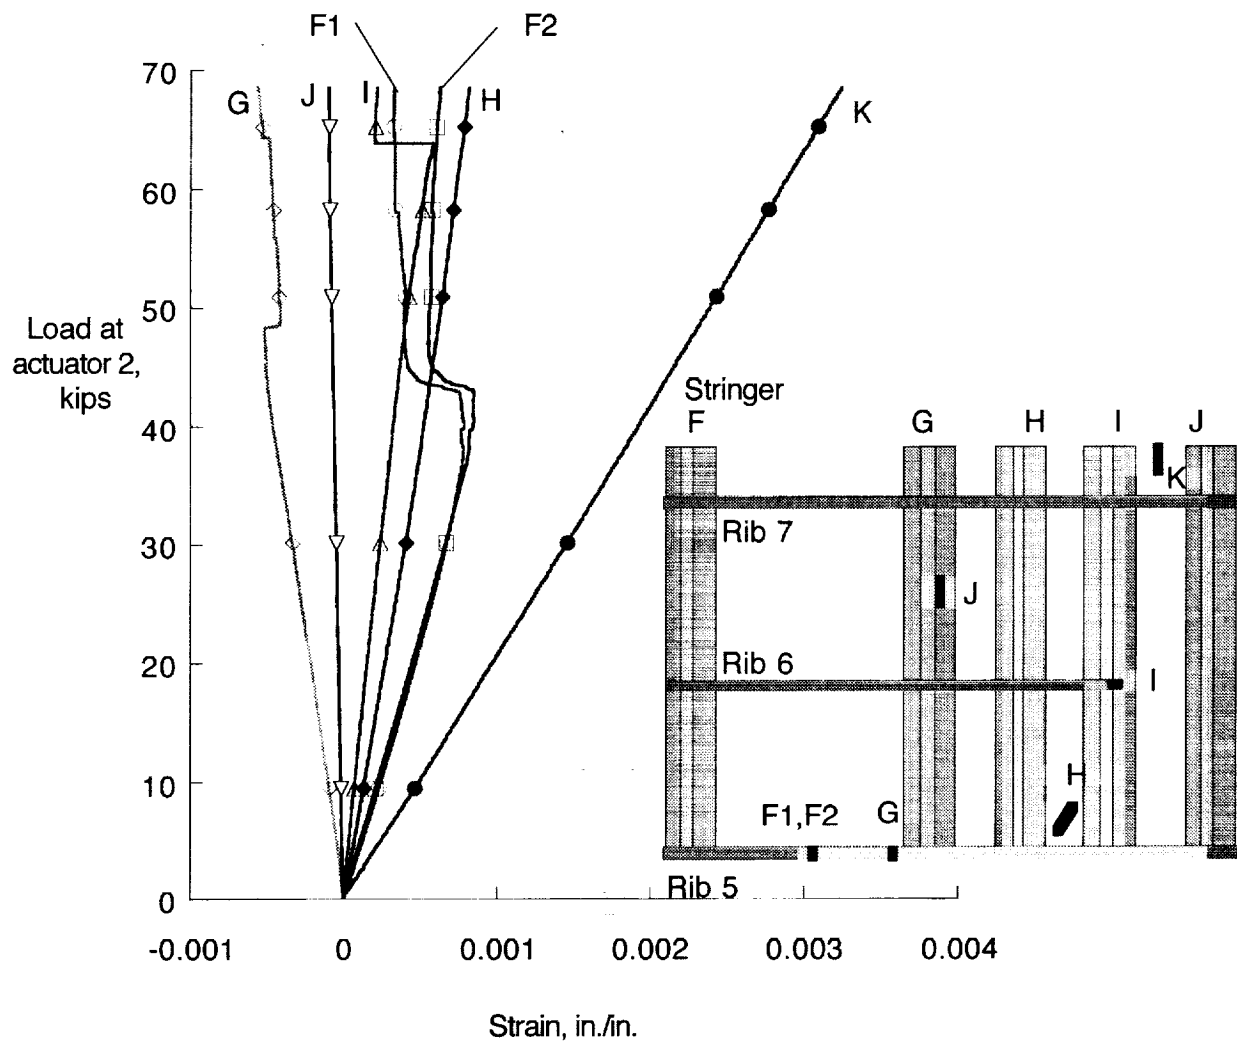
Measured strains in the main landing gear region are shown in figures 54-56. Strains in the upper and lower cover panels are shown in figures 54 and 55, respectively. Strains in the main landing gear doublers are shown in figure 56. Strain gage locations are shown in figure 9. All measured strains in the upper cover MLG region are linear except at stringer I. None of these strain values exceed 0.0035 in./in. The strain measured at stringer I shows discontinuities in slope at the load-strain curve for loading greater than approximately 50 kips. Strains at the lower cover intercostal at rib 5 show a discontinuity in the load-strain curve at a load of approximately 45 kips, as shown in figure 55. Strain in stringer I at rib 6 is linear for load less than about 65 kips, then decreases instantaneously. Several strains in the MLG doublers display nonlinear behavior. Strains near the edges of the upper and lower cover doublers are nonlinear and show discontinuities in the slope of the load-strain curve.

Figure 55. Strain in main landing gear area of the lower cover for loading to DLL in the 2.5G load condition. Strain gage locations are shown on figure 9.

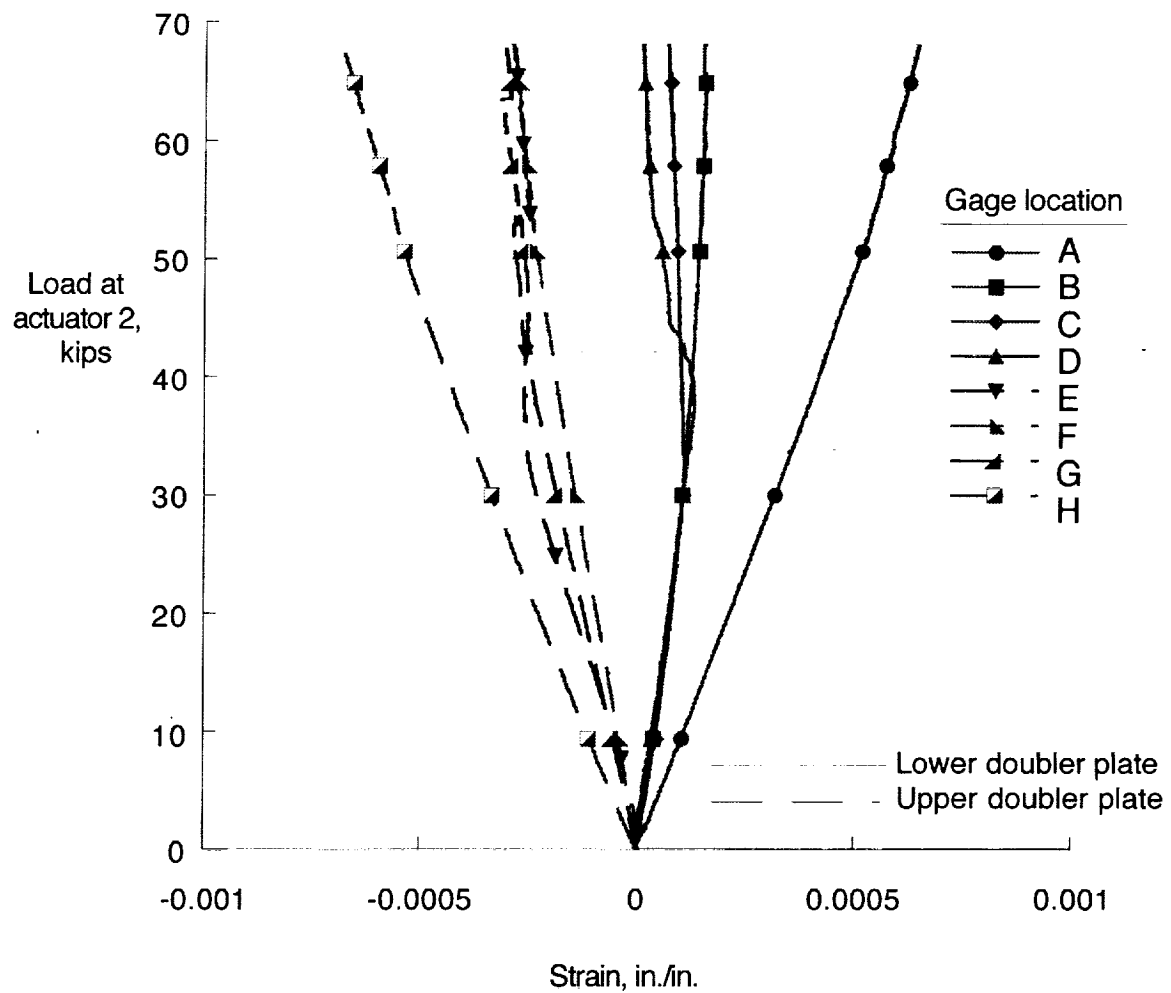
Figure 56. Strain in MLG doublers for loading to DLL in the 2.5G load condition. Strain gage locations are shown on figure 9.

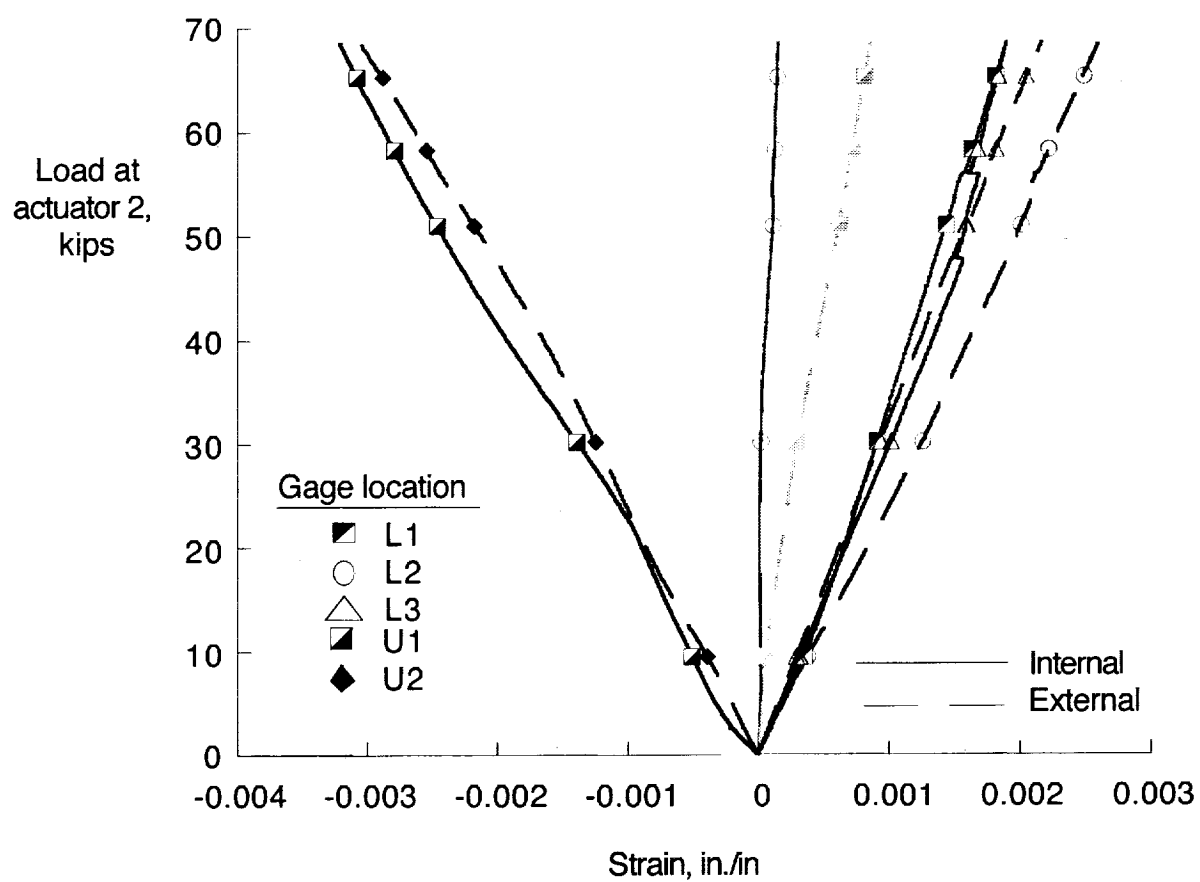
Measured strains in the upper and lower cover splice between the root transition box and the composite box are shown in figure 57. Strain gage locations are shown in figures 7 and 8. Open symbols represent lower cover panel strains, filled symbols represent strains on upper cover panel and half-filled symbols represent strains on the root transition box. All measured strains in the root splice region of the cover panels are approximately linear with increasing load except at location U2 where the load-strain curve is nonlinear. No strain exceeds 0.0035 in./in. in magnitude.

Figure 57. Strain in root region at DLL for 2.5G load condition. Strain gage locations are shown in figure 7 and 8.

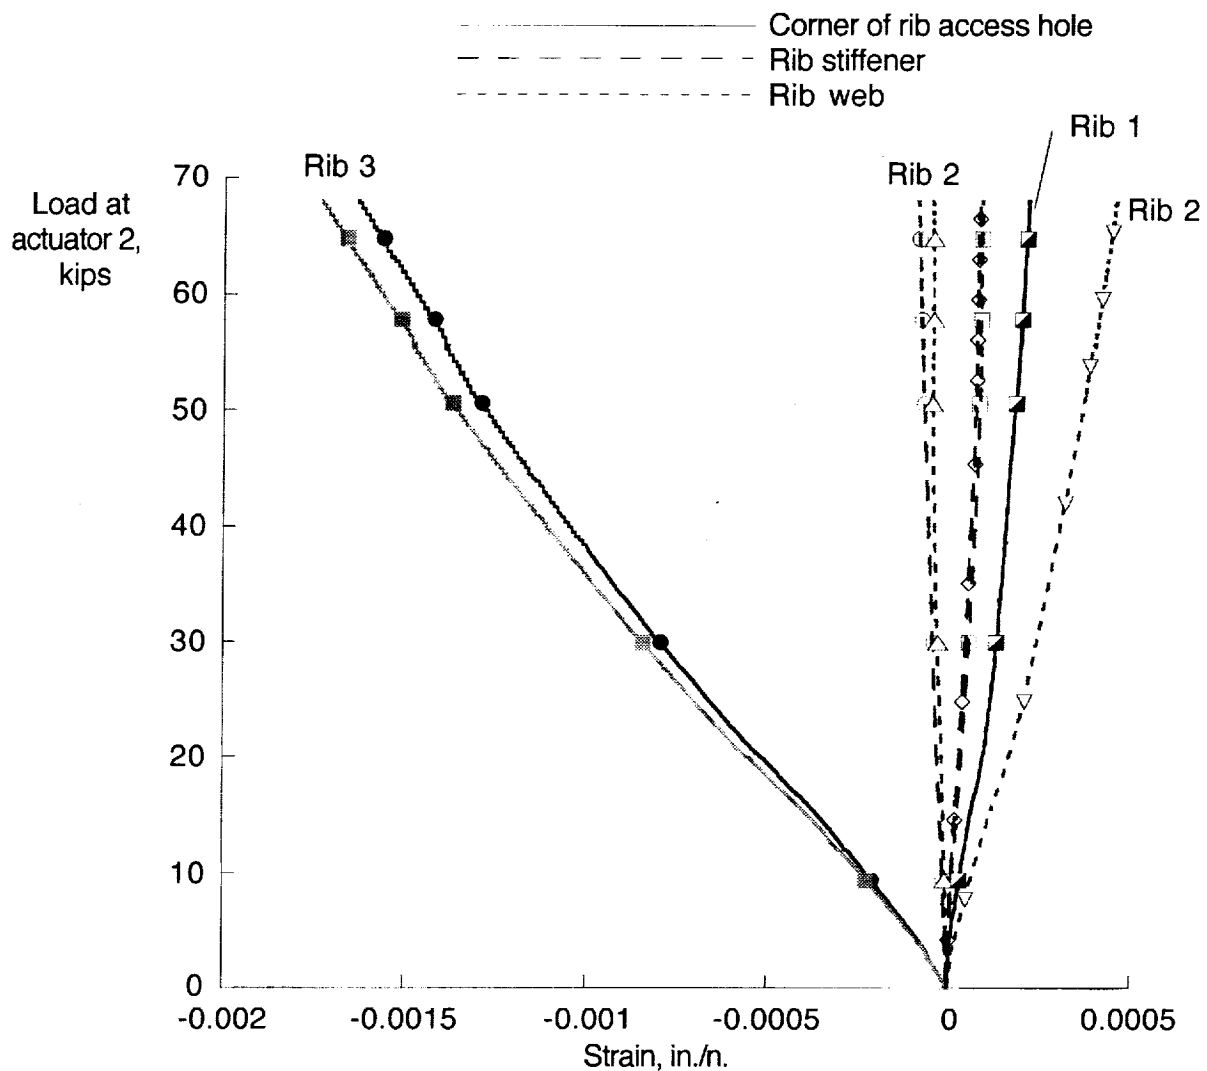
Measured strains in all ribs are less than 0.002 in./in. in magnitude. However, strains in ribs 2 through 15 display nonlinear behavior. Measured strain in ribs 2 and 3 are shown in figure 58. Measured strains in ribs 4, 5 and 6 are shown in figure 59. Measured strains in ribs 7, 8 and 9 are shown in figure 60 and are typical of ribs 10 through 15. Strain gage locations for ribs are shown in figure 11. For each figure, gage location is distinguished by line type and symbol. Even though strains are small, back-to-back strain gages show separation from the onset of loading, indicating the ribs are bending locally at the access hole in ribs 3 and 4 and globally in ribs 6-15. No back-to-back gages were placed on the rib away from the access hole in ribs 4 or 5 which could be used to determine if this bending behavior is restricted to the hole region.

Figure 58. Measured strain in ribs 1, 2 and 3 for loading up to DLL for the 2.5G load condition. Strain gage locations are shown in figures 11a, 11b, and 11c.

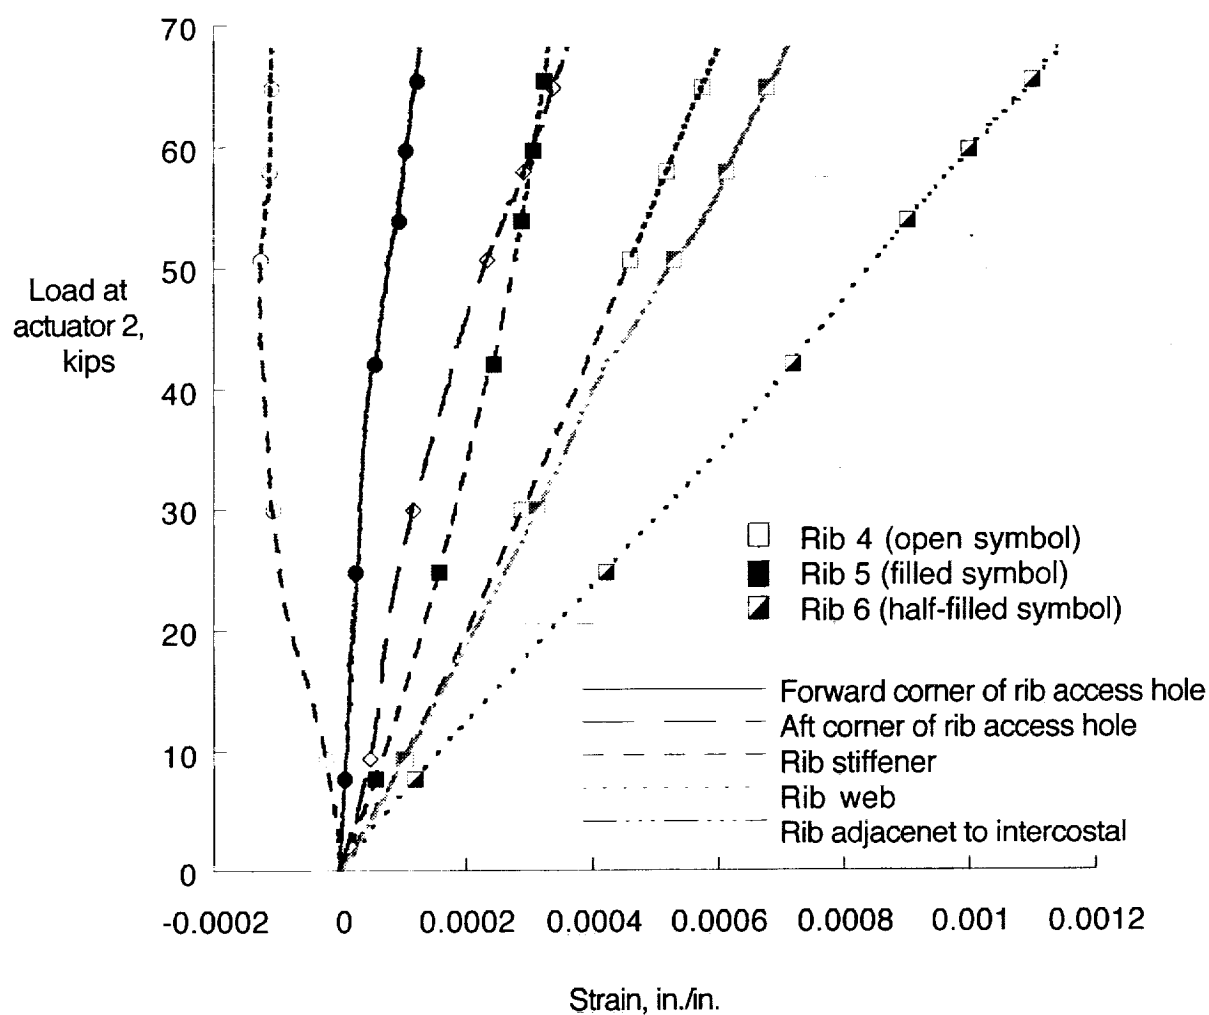
Figure 59. Strain in ribs 4, 5 and 6 for loading to DLL in the 2.5G load condition. Strain gage locations are shown in figure 11d and 11e.

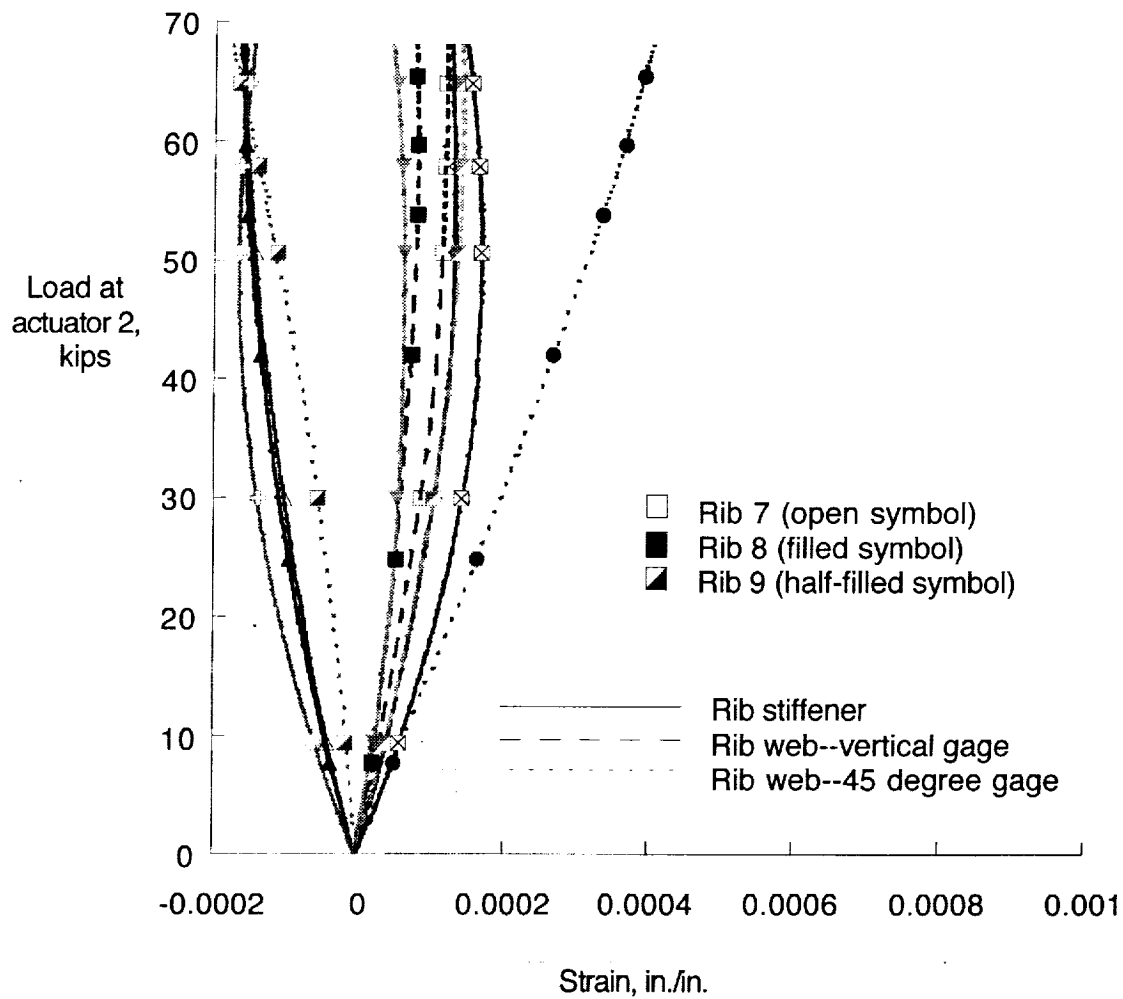
Figure 60. Strain in ribs 7, 8, and 9 for loading to DLL in the 2.5G load condition. Strain gage locations are shown in figure 11f.

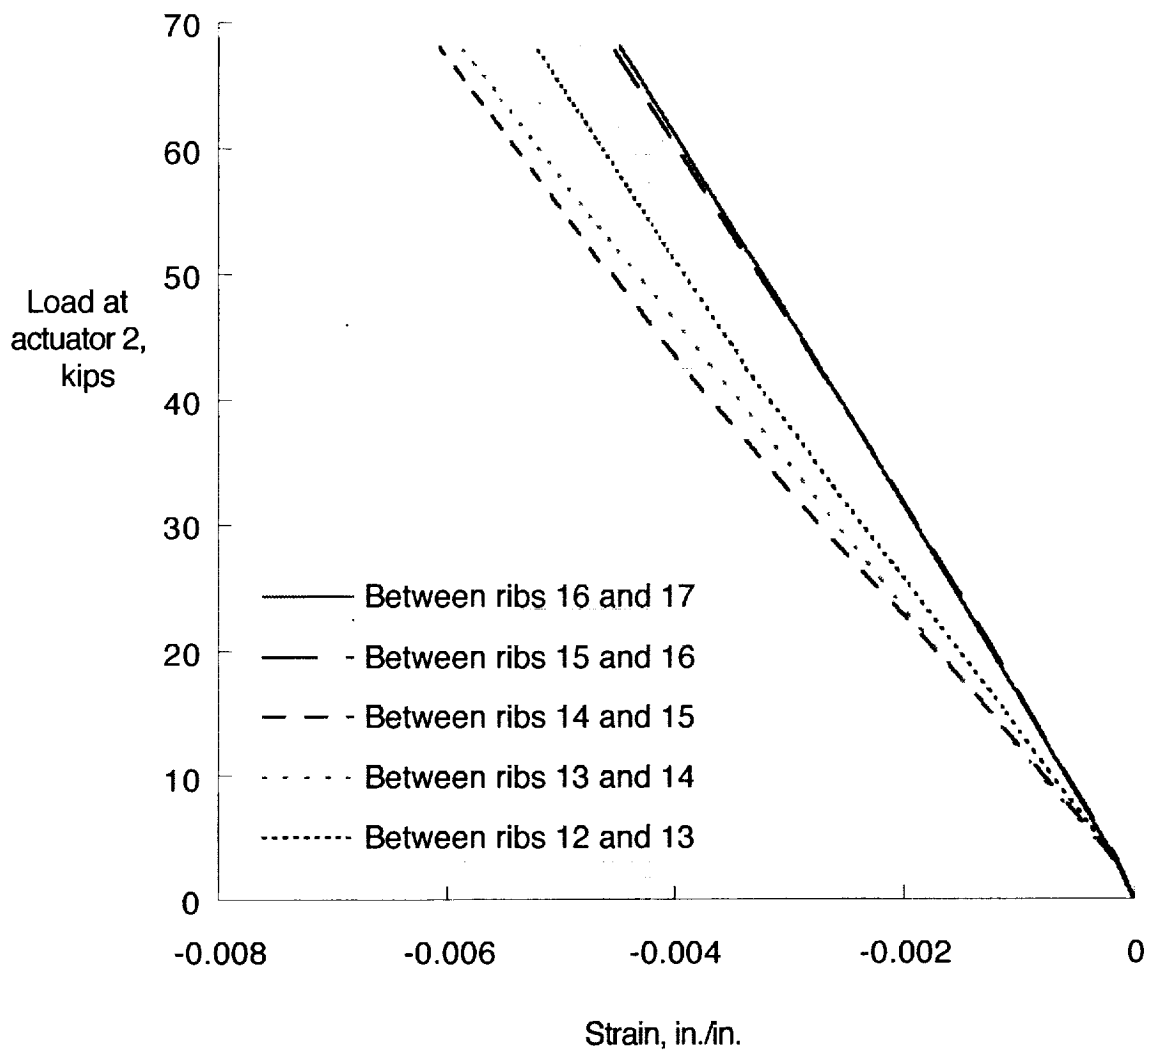
Measured strains in the front and rear spars are linear and with maximum values between -0.008 and 0.004 in./in. Strains measured in the front spar are shown in figure 61.

Figure 61. Strain in front spar for loading to DLL in the 2.5G load condition.

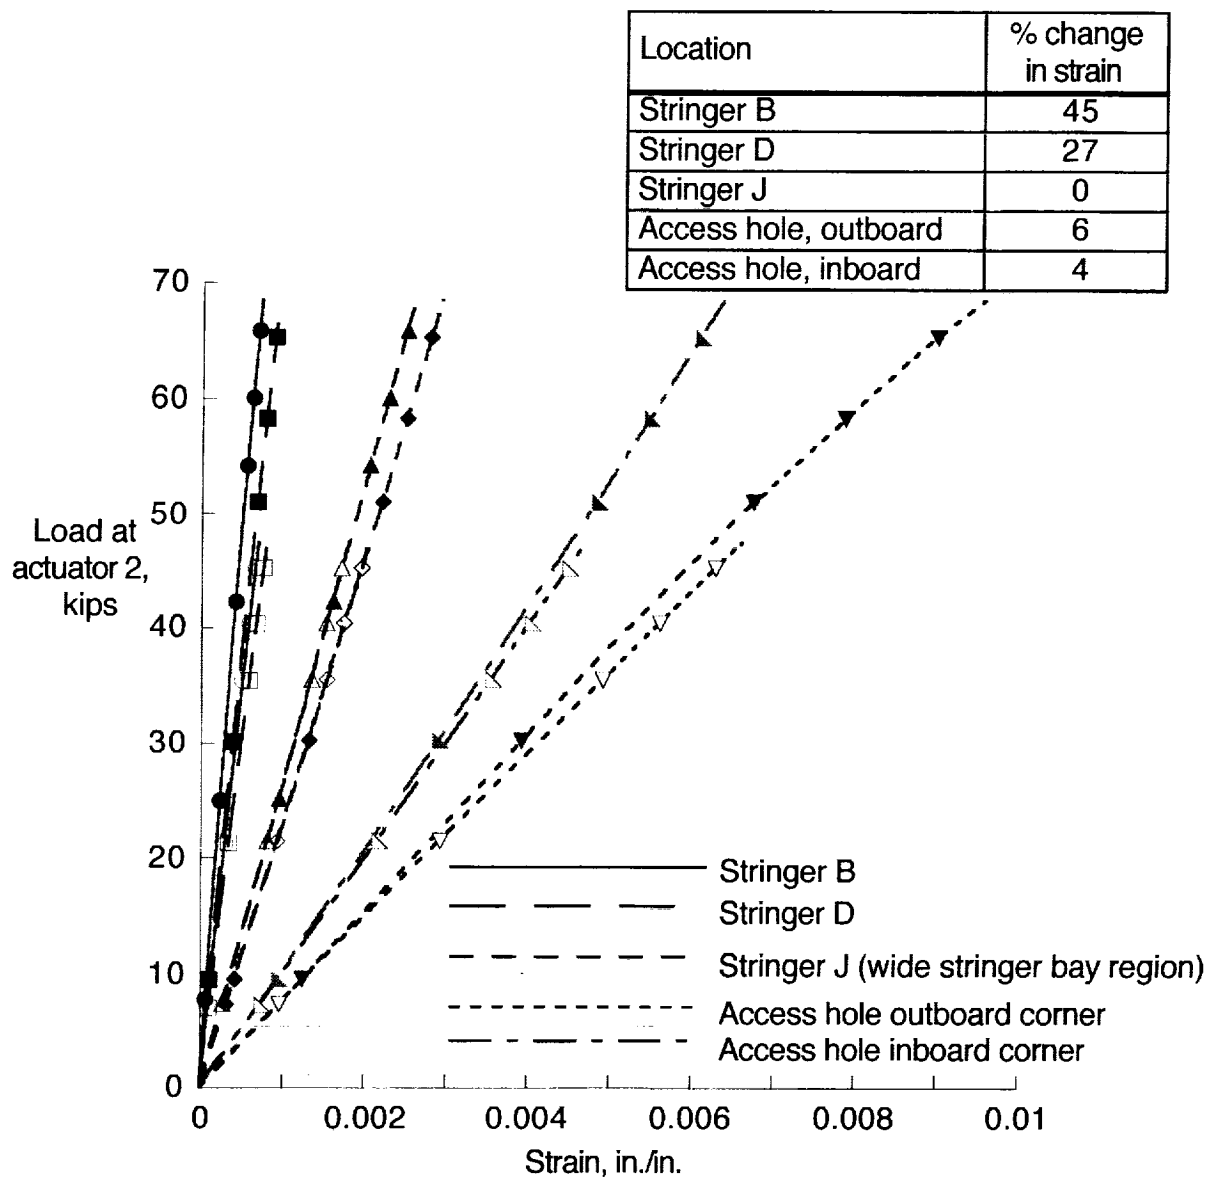
a) Measured strain in lower cover panel between ribs 8 and 9 away from damage site for sawcut and undamaged structure in 2.5G load condition

Strains in the same stringer bay as the sawcut but away from the sawcut tips are shown in figure 63a for the lower cover panel and figure 63b for the upper cover panel. Strains in the lower cover panel between ribs 8 and 9 at stringers B and D, at the access hole, and in the wide skin bay region outboard of stringer J are shown. Strain gage locations are shown in figure 7. Strains in the sawcut structure are 4 to 6 percent greater than strains in the undamaged structure at the access hole and approximately the same elsewhere in that bay.

Figure 63. Effect of sawcut damage on panel strains.
